**Flood Control Project Maintenance
Levee Inspections****LMA District Cover Sheet****Spring 2012 Levee Inspection Results****Reclamation District No. 2075 McMullin**

Levee Inspection Report By Mile - Spring 2012

Reclamation District No. 2075 McMullin

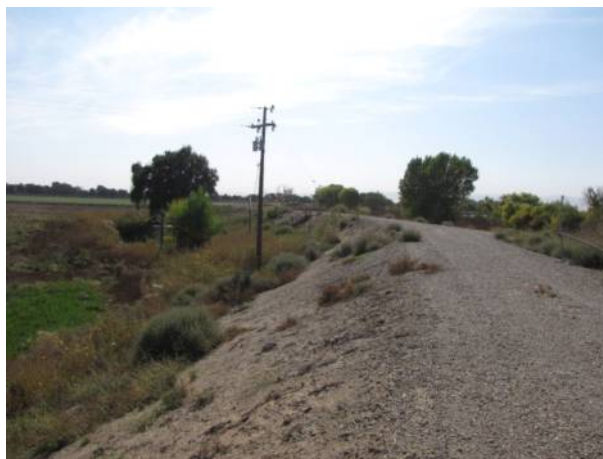
Levee Mile Report Line	5
Start Levee Mile	0.05
End Levee Mile	0.05
Location	Land Side
Category	Earthen Levee
Item	Vegetation

RD 2075 Looking downstream from levee mile 0.00 landside slope. Photo taken 11-02-2011.

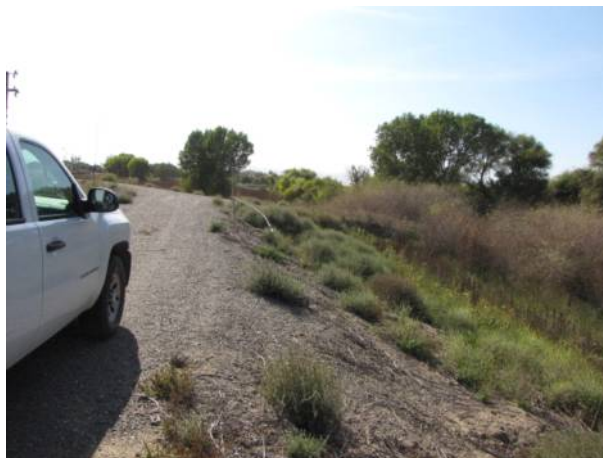
Levee Mile Report Line	6
Start Levee Mile	0.05
End Levee Mile	0.05
Location	Water Side
Category	Earthen Levee
Item	Vegetation

RD 2075 Looking downstream from levee mile 0.05 waterside. Photo taken 11-02-2011.

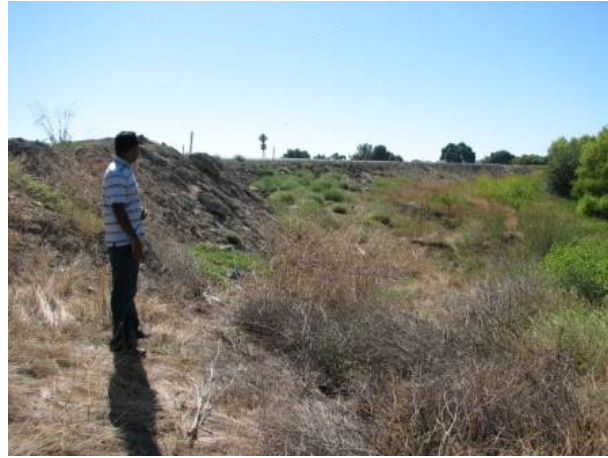
Levee Mile Report Line	20
Start Levee Mile	5.34
End Levee Mile	5.35
Location	Water Side
Category	Supplemental
Item	DWR Erosion Survey

Looking upstream of the site towards the levee crown.

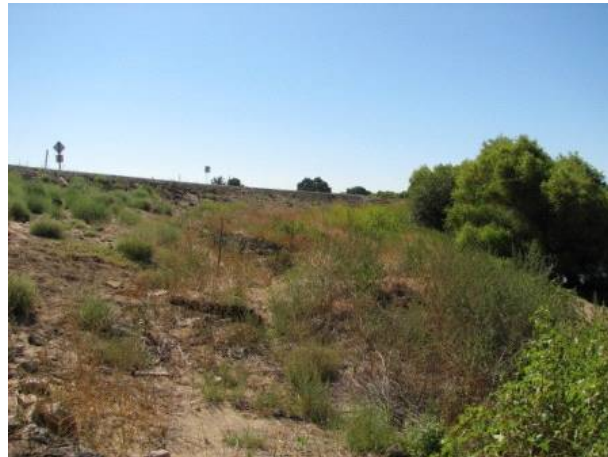
Levee Mile Report Line	20
Start Levee Mile	5.34
End Levee Mile	5.35
Location	Water Side
Category	Supplemental
Item	DWR Erosion Survey

Looking up to the levee crown at the added material.

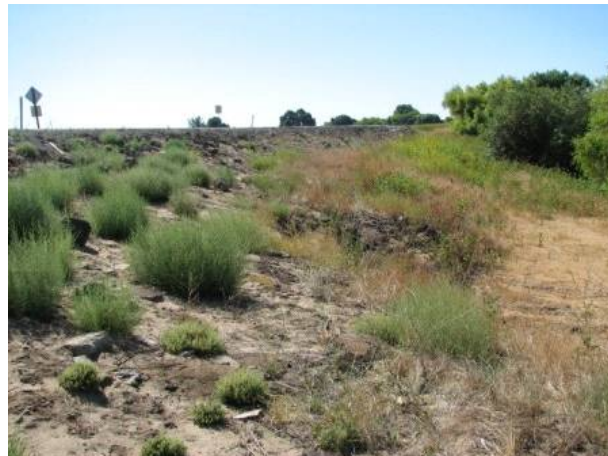
Levee Mile Report Line	20
Start Levee Mile	5.34
End Levee Mile	5.35
Location	Water Side
Category	Supplemental
Item	DWR Erosion Survey

Looking upstream of the erosion site

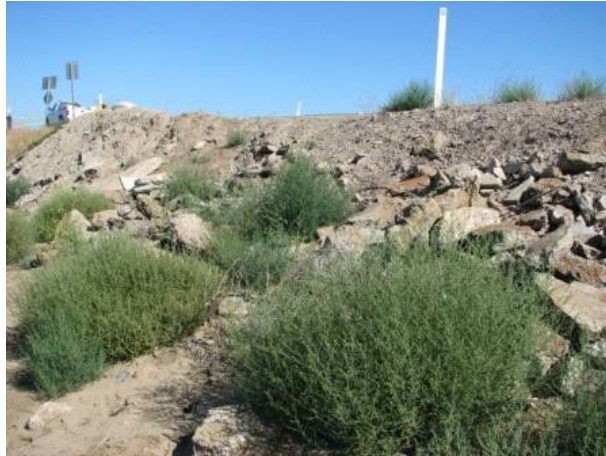
Levee Mile Report Line	20
Start Levee Mile	5.34
End Levee Mile	5.35
Location	Water Side
Category	Supplemental
Item	DWR Erosion Survey
Looking downstream from the added material to the levee	
phillips_s_20120306_318.jpg
